RE: Drinking Water Sampling – North Platte Intermediate School
90 Lewis St, Edgerton, Missouri 64444
Project Number: 923360

Drinking Water Assessment
 North Platte Intermediate School
 North Platte School District

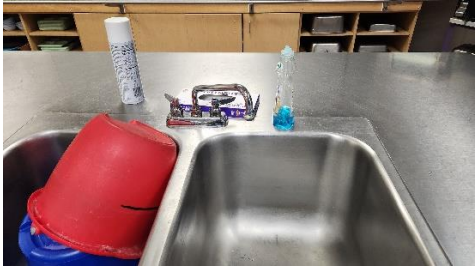
ID:	360-NPI-01	Location:	Kitchen	
Photo:

Manufacturer:	T&S Brass	
		Description:		
		Island Sink		
		Result:	<1.0	ppb
Recommended Action:		Date Sampled:	2/16/2024	By: JEA

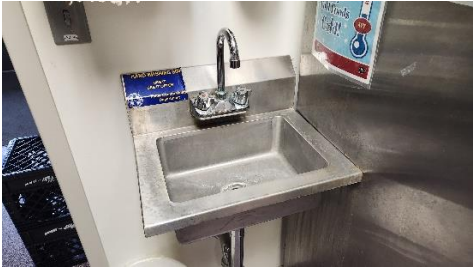
ID:	360-NPI-02	Location:	Kitchen	
Photo:

Manufacturer:	Unknown	
		Description:		
		Handwashing sink near gas stoves		
		Result:	12.5	ppb
Recommended Action:		Date Sampled:	2/16/2024	By: JEA
Replace Fixture/Unit and Resample

In accordance with the requirements set forth in Missouri Bill 681/662, fixtures exhibiting lead concentrations above 5 ppb must be remediated by replacement of lead-containing pipes, solder, fittings or fixtures with lead-free components, or the school shall install filtration at each point where water enters the building until such time as the source can be remediated. If installing a filter is not feasible, the school shall provide purified water at each outlet inventoried.

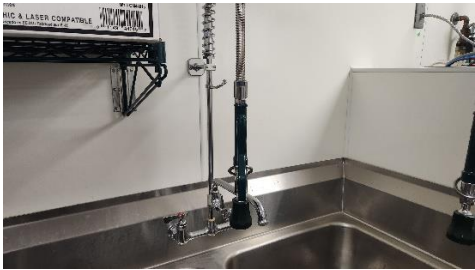
ID:	360-NPI-03	Location:	Kitchen	
Photo:

Manufacturer:	Krowne	
		Description:		
		Left dish sprayer		
		Result:	20.4	ppb
Recommended Action:		Date Sampled:	2/16/2024	By: JEA
Replace Fixture/Unit and Resample

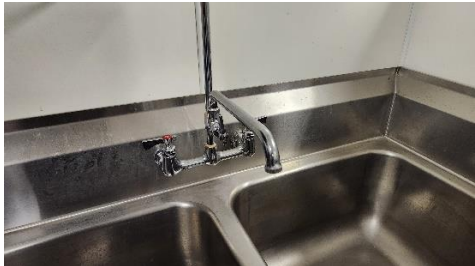
ID:	360-NPI-04	Location:	Kitchen	
Photo:

Manufacturer:	Unknown	
		Description:		
		Left handwashing faucet		
		Result:	71	ppb
Recommended Action:		Replace Fixture/Unit and Resample

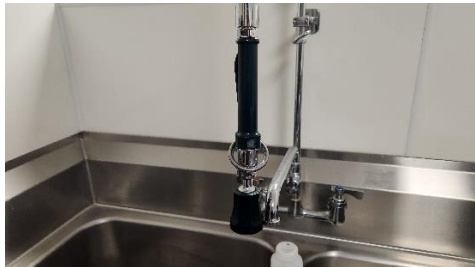
ID:	360-NPI-05	Location:	Kitchen	
Photo:

Manufacturer:	Krowne	
		Description:		
		Right dish sprayer		
		Result:	21.5	ppb
Recommended Action:		Replace Fixture/Unit and Resample

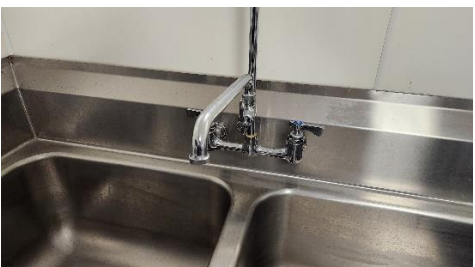
ID:	360-NPI-06	Location:	Kitchen	
Photo:

Manufacturer:	Unknown	
		Description:		
		Right handwashing faucet		
		Result:	164	ppb
Recommended Action:		Replace Fixture/Unit and Resample

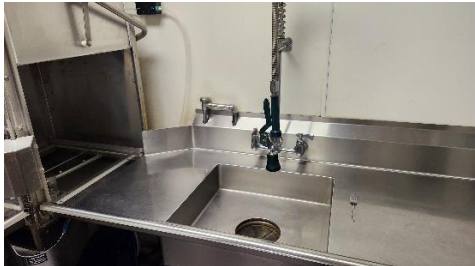
ID:	360-NPI-07	Location:	Kitchen	
Photo:

Manufacturer:	Krowne	
		Description:		
		Kitchen dish sprayer closer to entrance		
		Result:	29	ppb
Recommended Action:		Replace Fixture/Unit and Resample		
Date Sampled:	2/16/2024	By:	JEA

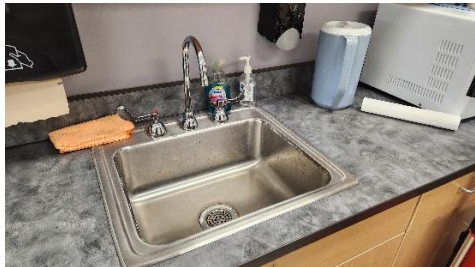
ID:	360-NPI-08	Location:	Room 137	
Photo:

Manufacturer:	Elkay	
		Description:		
		Handwashing Sink		
		Result:	<1.0	ppb
Recommended Action:				
Date Sampled:	2/16/2024	By:	JEA

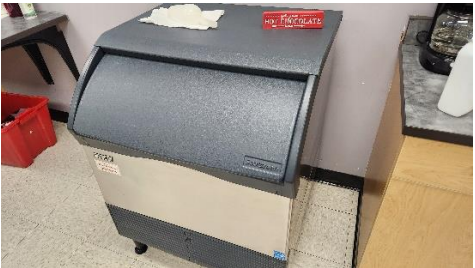
ID:	360-NPI-09	Location:	Room 137	
Photo:

Manufacturer:	Scotsman	
		Description:		
		Ice Machine		
		Result:	<1.0	ppb
Recommended Action:				
Date Sampled:	2/16/2024	By:	JEA

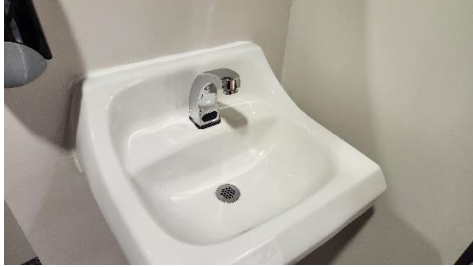
ID:	360-NPI-10	Location:	Restroom	
Photo:

Manufacturer:	Zurn	
		Description:		
		Handwashing Sink		
		Result:	1.4	ppb
Recommended Action:		Date Sampled:	2/16/2024	By: JEA

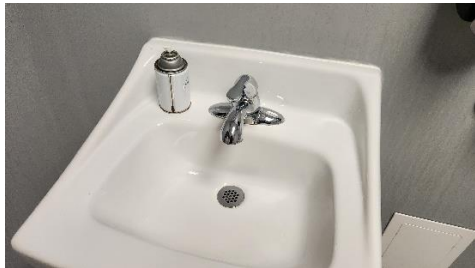
ID:	360-NPI-12	Location:	FEMA Restroom	
Photo:

Manufacturer:	Delta	
		Description:		
		Right restroom handwashing sink		
		Result:	<1.0	ppb
Recommended Action:		Date Sampled:	2/16/2024	By: JEA

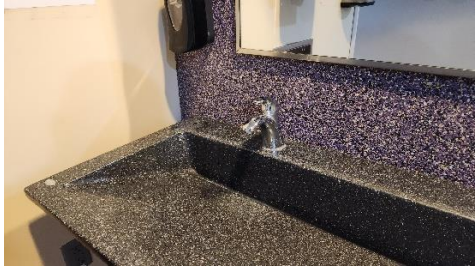
ID:	360-NPI-13	Location:	Hall Across from Rm 115	
Photo:

Manufacturer:	PF	
		Description:		
		Left handwashing sink in girls restroom		
		Result:	<1.0	ppb
Date Sampled:		2/16/2024	By:	JEA
Recommended Action:

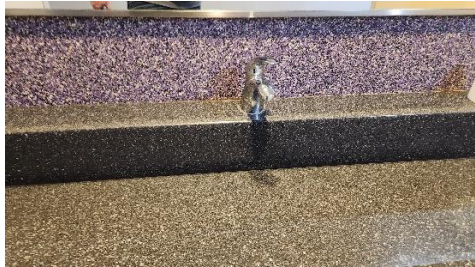
ID:	360-NPI-14	Location:	Hall Across from Rm 115	
Photo:

Manufacturer:	PF	
		Description:		
		Middle handwashing sink in girls restroom		
		Result:	<1.0	ppb
Date Sampled:		2/16/2024	By:	JEA
Recommended Action:

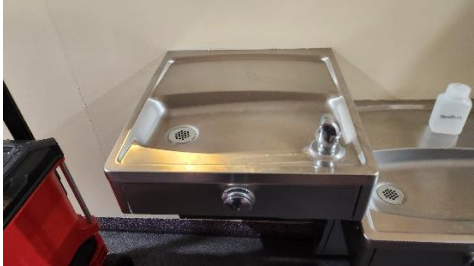
ID:	360-NPI-16	Location:	Hall Across from Rm 115	
Photo:

Manufacturer:	Elkay	
		Description:		
		Left drinking fountain bubbler near restrooms		
		Result:	<1.0	ppb
Date Sampled:		2/16/2024	By:	JEA
Recommended Action:

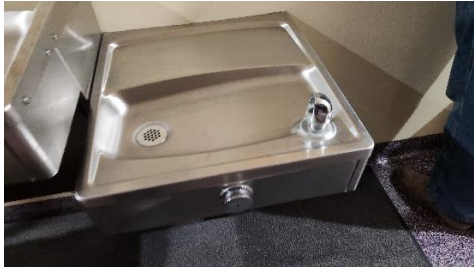
ID:	360-NPI-17	Location:	Hall Across from Rm 115	
Photo:

Manufacturer:	Elkay	
		Description:		
		Right drinking fountain bubbler near restroom		
		Result:	<1.0	ppb
Date Sampled:		2/16/2024	By:	JEA
Recommended Action:

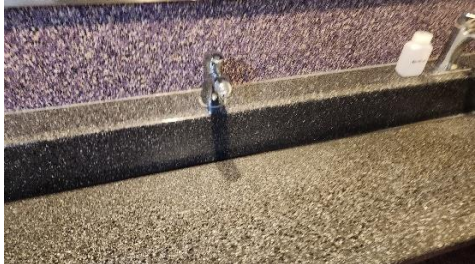
ID:	360-NPI-19	Location:	Hall Across from Rm 115	
Photo:

Manufacturer:	PF	
		Description:		
		Middle handwashing sink in boys restroom		
		Result:	<1.0	ppb
Date Sampled:		2/16/2024	By:	JEA
Recommended Action:

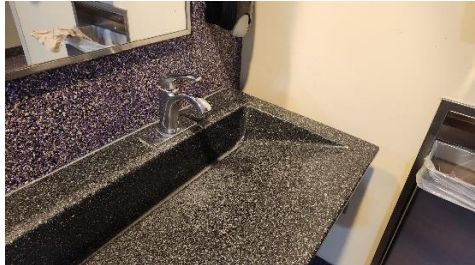
ID:	360-NPI-20	Location:	Hall Across from Rm 115	
Photo:

Manufacturer:	PF	
		Description:		
		Right handwashing sink in boys restroom		
		Result:	<1.0	ppb
Date Sampled:		2/16/2024	By:	JEA
Recommended Action:

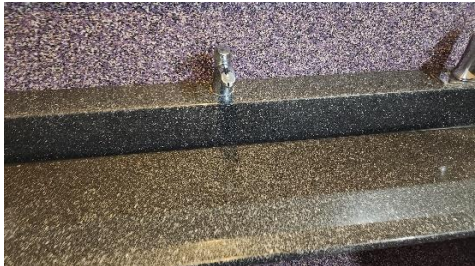
ID:	360-NPI-22	Location:	Hall near Café	
Photo:

Manufacturer:	PF	
		Description:		
		Middle handwashing sink in girls restroom		
		Result:	<1.0	ppb
Date Sampled:		2/16/2024	By:	JEA
Recommended Action:

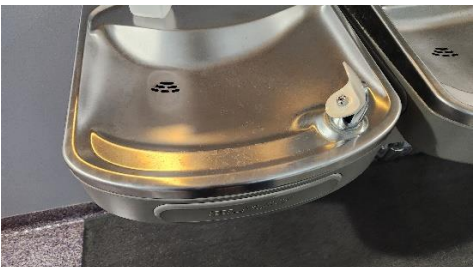
ID:	360-NPI-24	Location:	Cafeteria	
Photo:

Manufacturer:	Elkay	
		Description:		
		Left drinking fountain bubbler		
		Result:	<1.0	ppb
Date Sampled:		2/16/2024	By:	JEA
Recommended Action:

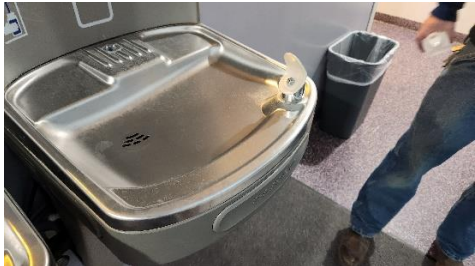
ID:	360-NPI-25	Location:	Cafeteria	
Photo:

Manufacturer:	Elkay	
		Description:		
		Right drinking fountain bubbler		
		Result:	<1.0	ppb
Date Sampled:		2/16/2024	By:	JEA
Recommended Action:

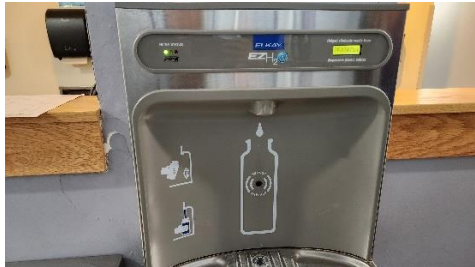
ID:	360-NPI-26	Location:	Cafeteria	
Photo:

Manufacturer:	Elkay	
		Description:		
		Right drinking fountain bottle filler		
		Result:	<1.0	ppb
Date Sampled:		2/16/2024	By:	JEA
Recommended Action:

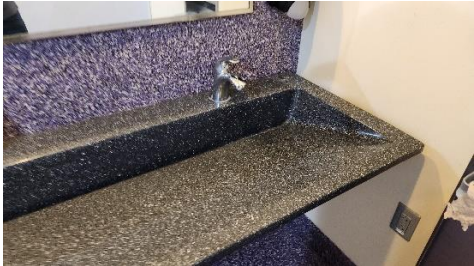
ID:	360-NPI-28	Location:	Boys Restroom in Café	
Photo:

Manufacturer:	PF	
		Description:		
		Right handwashing sink		
		Result:	<1.0	ppb
Recommended Action:		Date Sampled:	2/16/2024	By: JEA

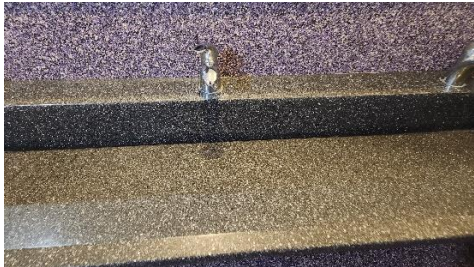
ID:	360-NPI-29	Location:	Boys Restroom in Café	
Photo:

Manufacturer:	PF	
		Description:		
		Middle handwashing sink		
		Result:	<1.0	ppb
Recommended Action:		Date Sampled:	2/16/2024	By: JEA

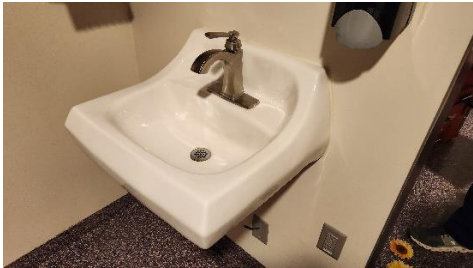
ID:	360-NPI-30	Location:	Office Restroom	
Photo:

Manufacturer:	unknown	
		Description:		
		Handwashing sink		
		Result:	<1.0	ppb
Recommended Action:		Date Sampled:	2/16/2024	By: JEA

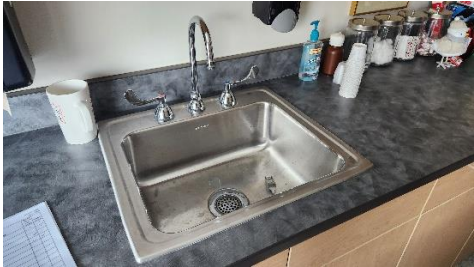
ID:	360-NPI-31	Location:	Nurse's Office	
Photo:

Manufacturer:	Elkay	
		Description:		
		Handwashing sink		
		Result:	4.1	ppb
Date Sampled:	2/16/2024	By:	JEA	
Recommended Action:
